REPORT ON REMEDIAL ACTIONS  
LONGVIEW FIBRE COMPANY  
SEATTLE, WASHINGTON

LONGVIEW FIBRE COMPANY  
P.O. Box 639  
Longview, Washington 98632

CH2M HILL  
February 1988

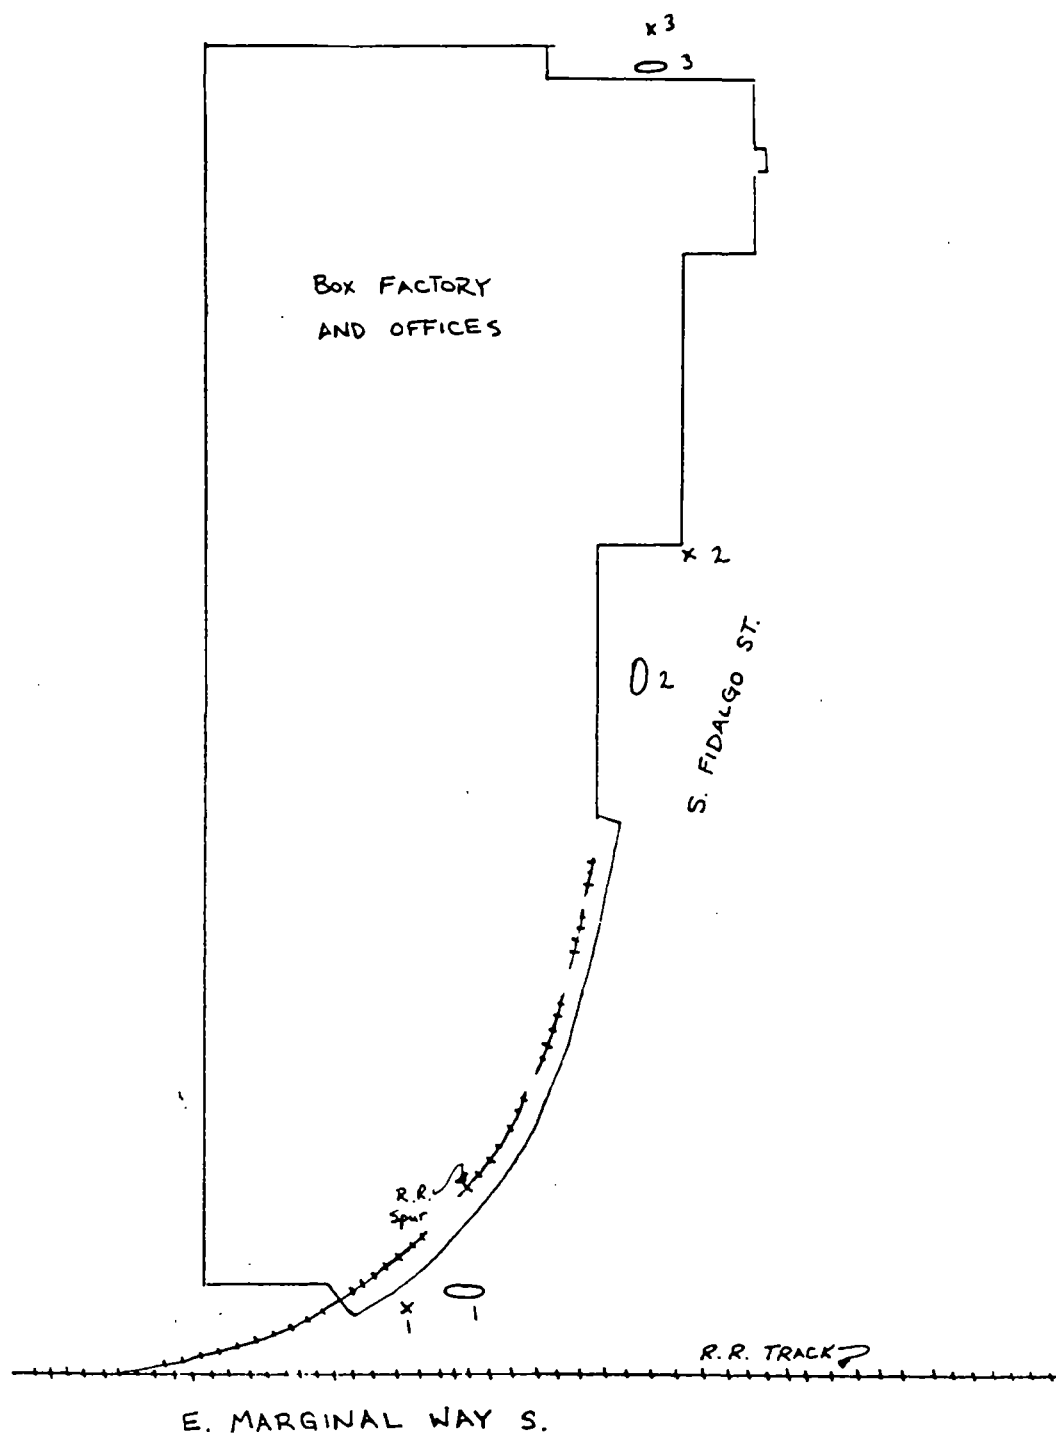
FIGURE 1  
LONGVIEW FIBRE COMPANY  
SEATTLE, WASHINGTON

In August 1987, three underground tanks used to store liquid hydrocarbons were removed from property owned by the Longview Fibre Corporation. The location of the tanks is shown in Figure 1. Tank 1 was a 12,000-gallon tank used to store Bunker C oil for approximately 2 years before its removal. Prior to that it contained No. 2 diesel. Tank 2 was a 7,500-gallon tank that stored diesel from 1980 until 1987. Prior to 1980, it contained gasoline. Tank 3 was a 1,000-gallon tank used to store fuel oil. It was abandoned in 1980. Details of the tank removal are discussed in "Underground Storage Tank Removals, Longview Fibre Company Seattle Facility" submitted to Longview Fibre on December 8, 1987.

Local water table depths are known to be shallow, making it possible for hydrocarbons leaked from the tanks to mix with shallow groundwater. Three shallow monitoring wells were installed in the vicinity of the buried tank locations, as shown in Figure 1. The purpose of installing these wells was to help characterize shallow site stratigraphy, to provide data needed to make an initial evaluation of groundwater flow beneath the site, and to determine whether the groundwater contained detectable quantities of floating and/or dissolved hydrocarbons.

SITE PLAN WITH APPROXIMATE  
TANK AND WELL LOCATIONS

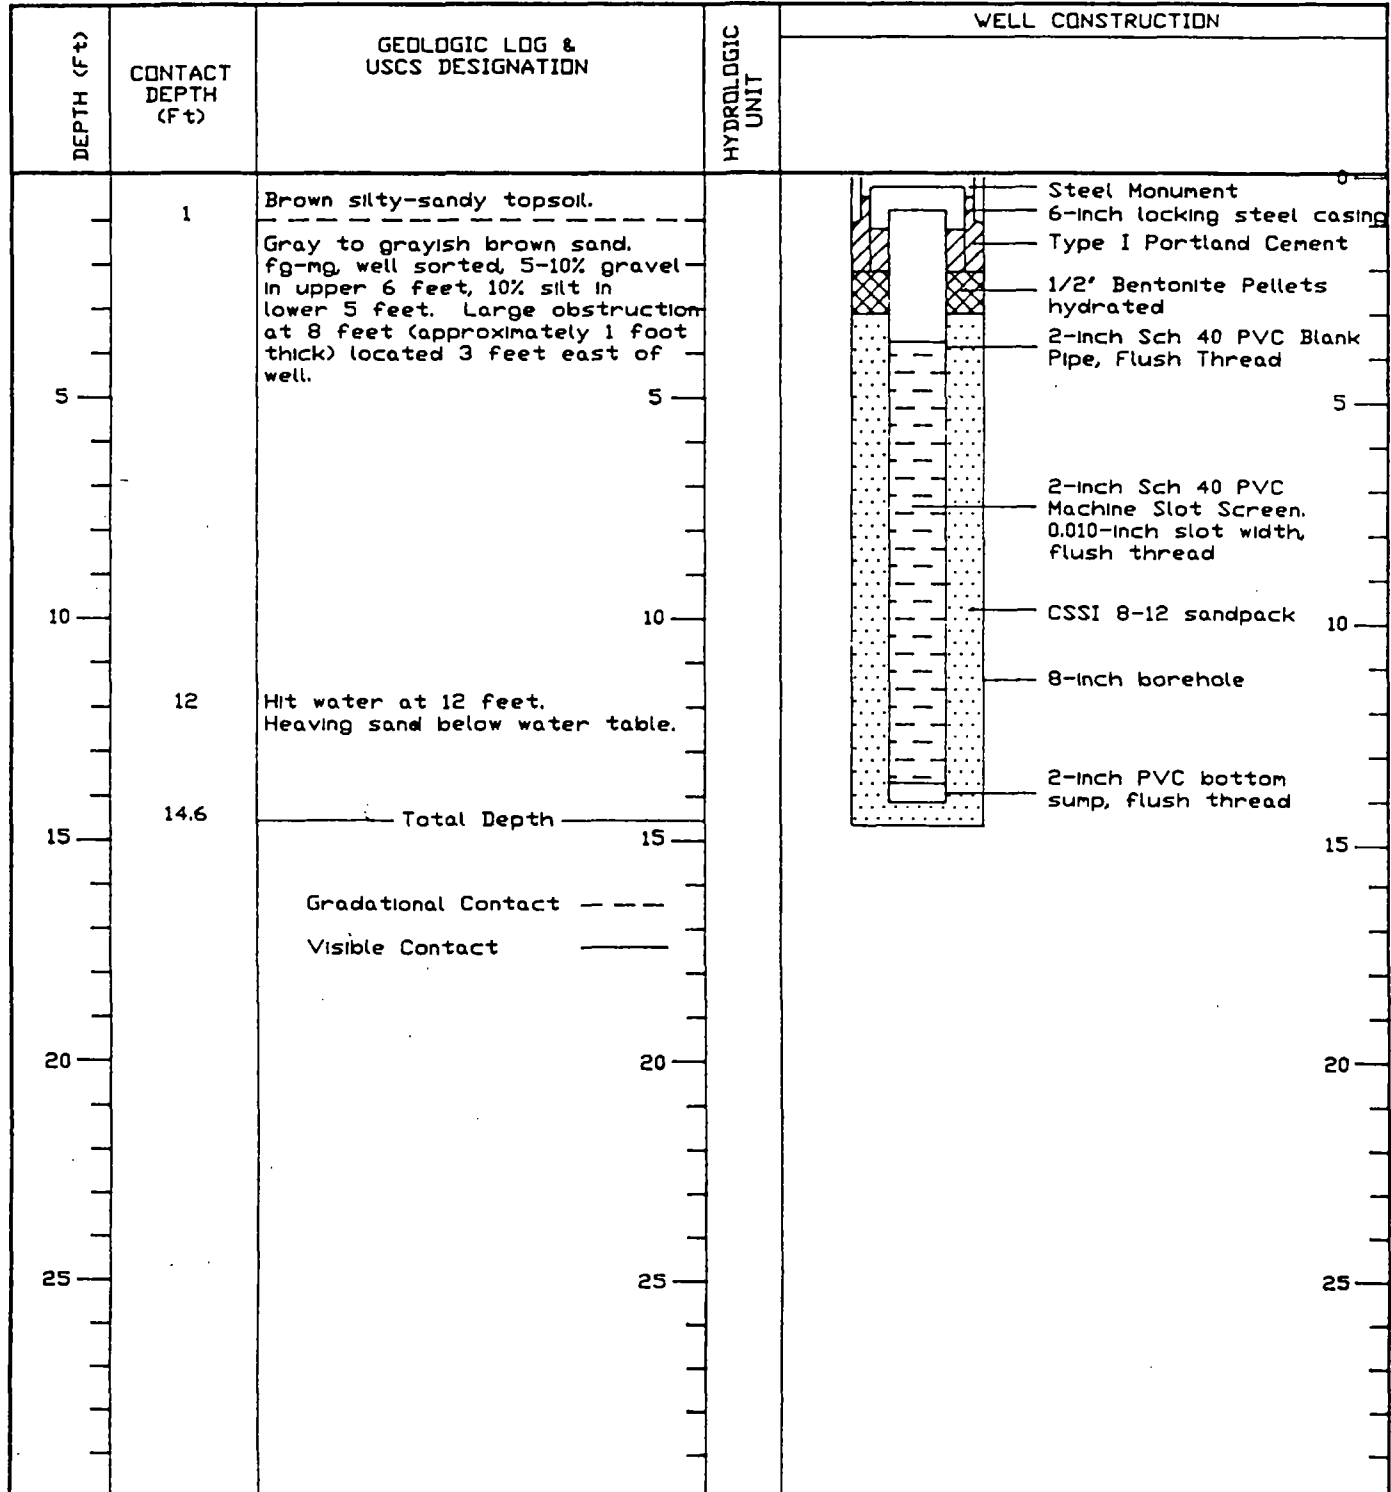
Figure 2

All three monitoring wells were drilled and installed by Pacific Testing Laboratories using a mobile B-75 hollow-stem auger rig. Each well was installed using the 4-inch inside diameter (ID) auger as temporary casing to ensure the proper placement of the screen assembly, sand pack, and upper seal. All drilling and well installation were supervised by a CH2M HILL hydrogeologist. Well completion details and lithologic logs are presented in Figures 2 through 4.

PROJECT Longview Fiber LOCATION Adj. to RR tracks in front of Bldg  
 ELEVATION, NGVD (Top of Well Casing) 9.54 SURFACE ELEVATION, NGVD 9.82  
 WATER LEVEL ELEVATION, NGVD \_\_\_\_\_ START DATE 10/27/87  
 DRILLING CONTRACTOR Pacific Testing Labs FINISH DATE 10/28/87  
 DRILLING METHOD Mobile B-75 Hollow Stem Auger
